Hunters Hill Village

Pedestrian Access & Mobility Plan (PAMP)

Hunter's Hill Council
Final Report | September 2014

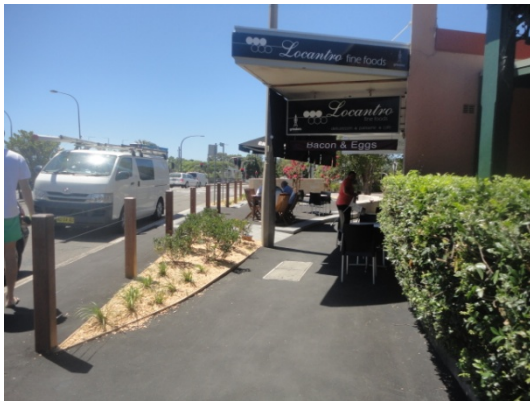
Along Gladesville Road (east of Ryde Road) the condition of footpaths is generally of high quality, with recent public domain works completed adjacent to Joubert Street (Photograph 1). Outside the core of the study area however, there are a number of areas where the footpath surface is cracked and uneven. This presents a trip hazard, particularly for elderly and less mobile users.

Photograph 1: Gladesville Road footpath

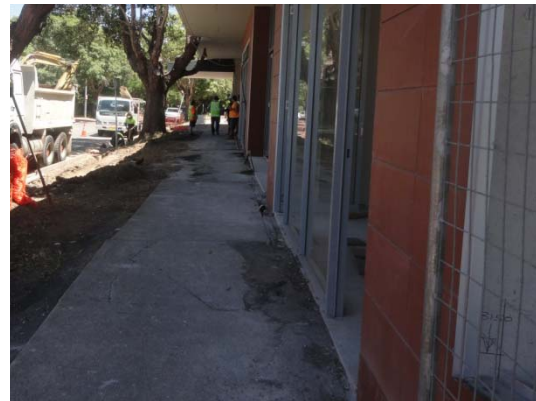
Some footpaths were observed to be under transition adjoining construction sites, such as that shown in Photograph 2 on Gladesville Road.

Photograph 2: Footpaths under transition adjoining construction sites

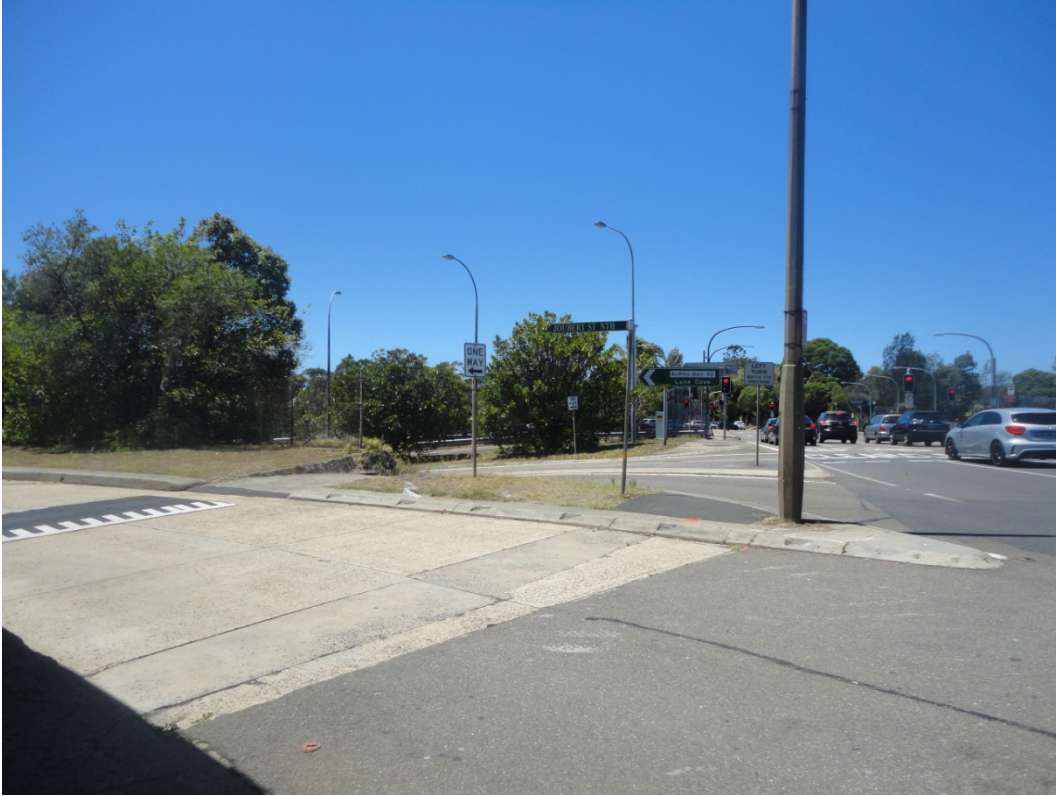
Photograph 3: Burns Bay Road northern crossing

It should be noted that crashes involving pedestrians are usually under-reported and may actually be higher. Arup has been made aware of an incident involving a school aged student in recent years crossing the northern side of Burns Bay Road which has not been included in the RMS database. The issue of pedestrian safety at this crossing (see Photograph 3) will be important to consider during the PAMP audit process.

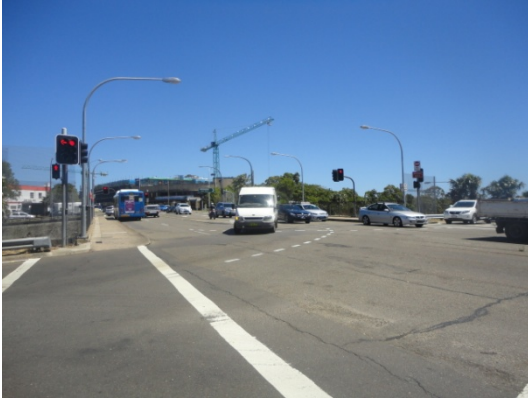
Severance caused by Burns Bay Road

The Hunter's Hill Village is unique in that it is located directly adjacent to an 80km/h freeway (Burns Bay Road). The presence of this road presents a major barrier to walking, particularly connections between the Village Centre and uses on the eastern side of the road including Hunter's Hill High School. Maximising the safety of users at this location has formed a key consideration of this PAMP.

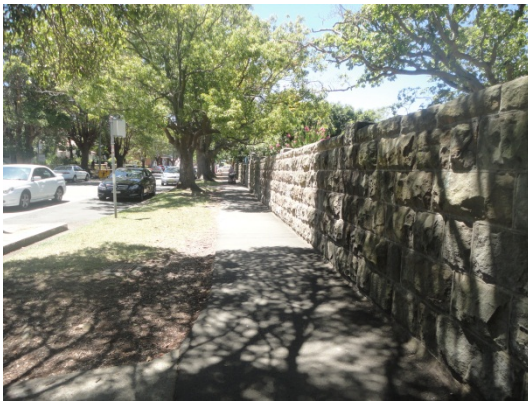
Concentration of aged care facilities

A high number of aged care facilities are located along Gladesville Road. It is therefore important the pedestrian network supporting these facilities provide pedestrian infrastructure that are an appropriate width, are of high quality and meet DDA standards. Any trip hazards along footpaths need to be identified to ensure the safety of these users.

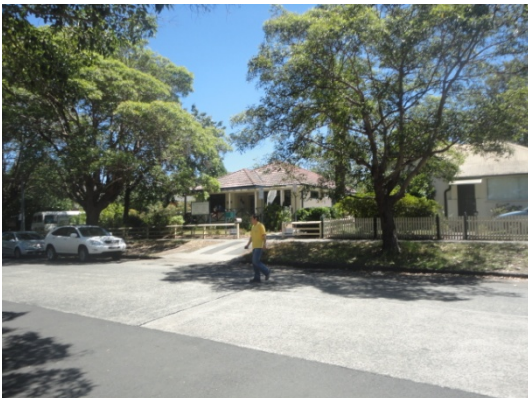
Access across Gladesville Road

There is a strong pedestrian desire line across Gladesville Road particularly to travel to and from the aged care facilities located along this corridor.

There are currently no pedestrian crossing facilities on Gladesville Road between Ryde Road and Mary Street, a distance of approximately 600m.

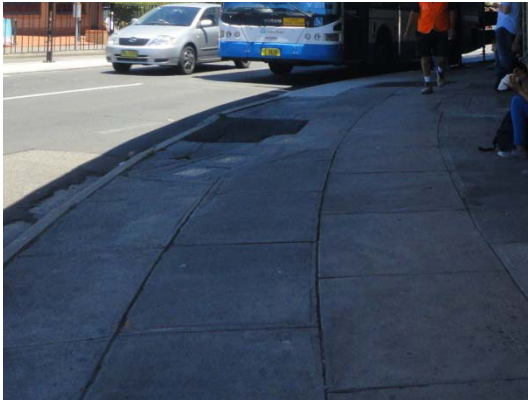
Quality of Footpaths

A number of footpaths in the study area were observed to be either cracked or uneven – presenting trip hazards. Given the high proportion of elderly users utilising these footpaths, it is important the PAMP identifies areas of where footpaths require remedial action.

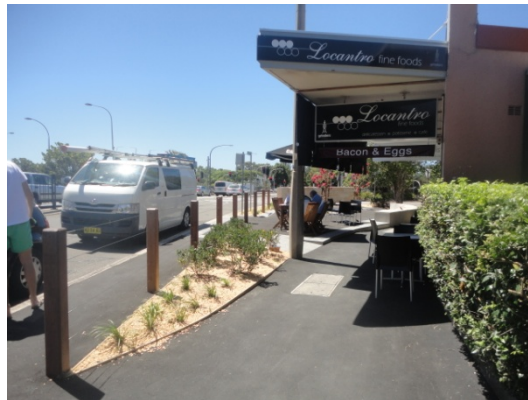
Public domain improvements

Recent public domain improvements along Gladesville Road provide high pedestrian amenity environment, good quality pavements, and encourage pedestrians to stop and rest in the Village area. The PAMP should ensure these improvements are implemented throughout the Village Centre in accordance with the Hunter's Hill public domain guidelines.

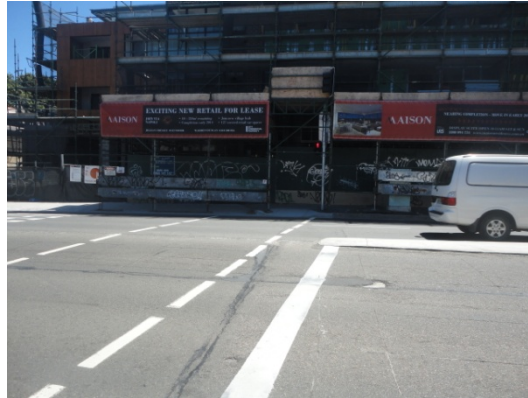
Future developments

A number of sites within the study area have been identified, or are currently under construction for development. It is important that this PAMP considers the implications of these developments with respect to the adjacent pedestrian environment.

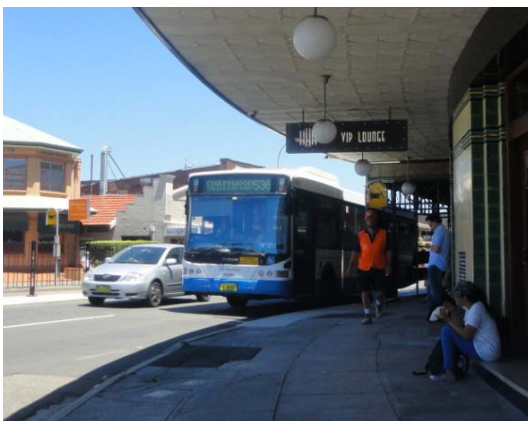
Access to bus stops

Bus stops are currently provided on Gladesville Road near Burns Bay Road (adjacent to the Hunter's Hill Hotel). A recommendation arising out of a traffic study prepared by Council involved relocating bus services utilising these stops to Burns Bay Road.

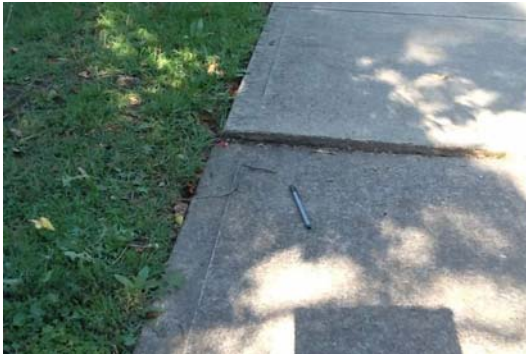
There were a number of locations throughout the study area where the footpath was identified as uneven or cracked. Cracks, cavities and uneven footpaths appear due to wear/age, poor drainage/sub-base and nearby tree roots. Some locations of where footpaths were in poor condition are shown below.

Matthew Street (western side)

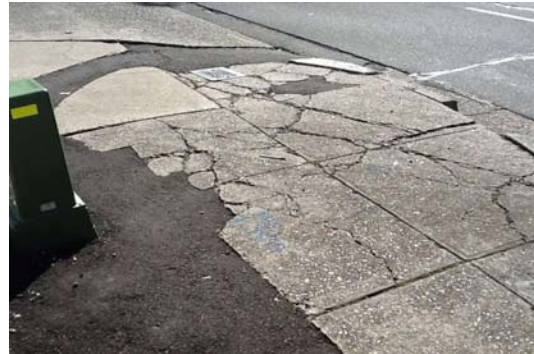
Ryde Road (southern side)

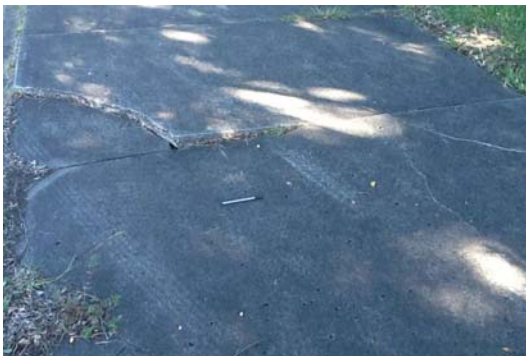
Burns Bay Road NB off-ramp (western side)

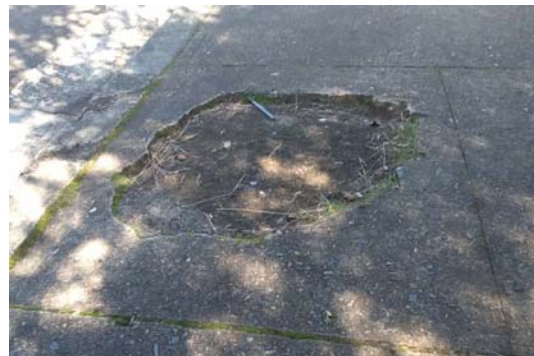
Reiby Road (western side)

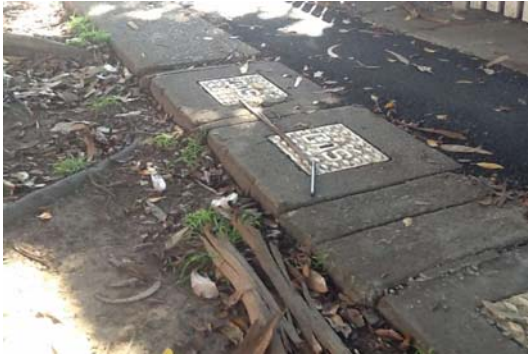
Ryde Road (northern side)

There were also a number of locations where the footpath was uneven due to manhole covers. These locations are illustrated below:

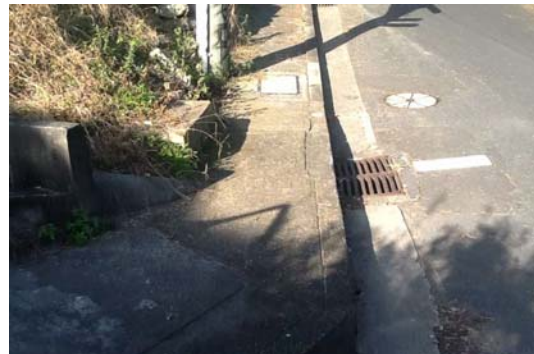
King Street (northern side)

The width of the footpath was observed during the audit process. Width was assessed against standards to the minimum required width (for DDA compliance) of 1.2m. It was also assessed on existing evidence of wear (of the nature strip) to determine pedestrian demand. Examples of locations where footpaths were observed to be narrow are outlined below:

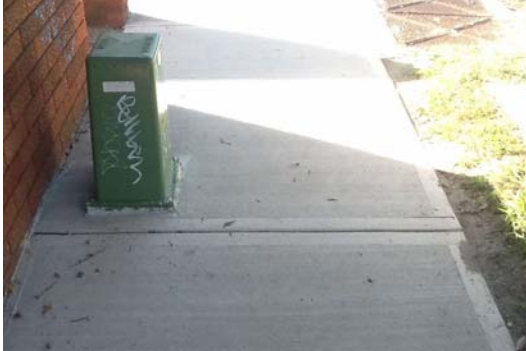
Joubert Street (western side)

There were also a number of footpaths that meet the minimum standards, but contain pinch points that reduce the available width (due to obstructions). Obstructions include telegraph poles, roadside signage and service boxes. Some of these locations are outlined below:

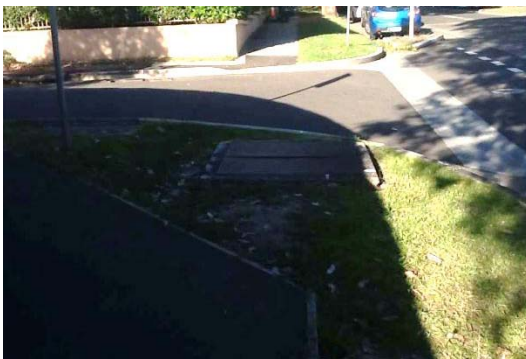
Gladesville Road (at Luke Street) not aligned

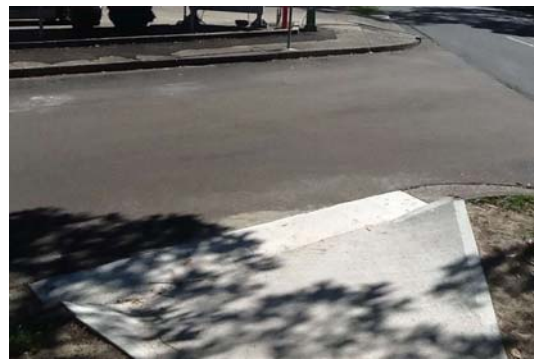
Ryde Road (at Matthew Street) missing kerb ramp

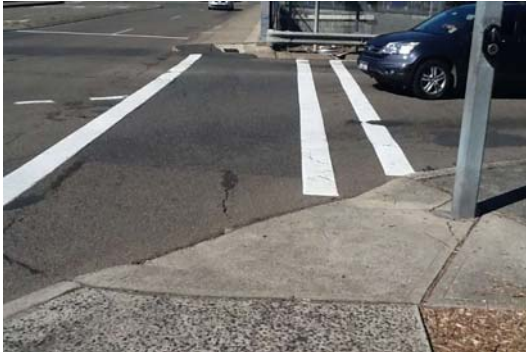
Ryde Road (at Burns Bay Road) not aligned

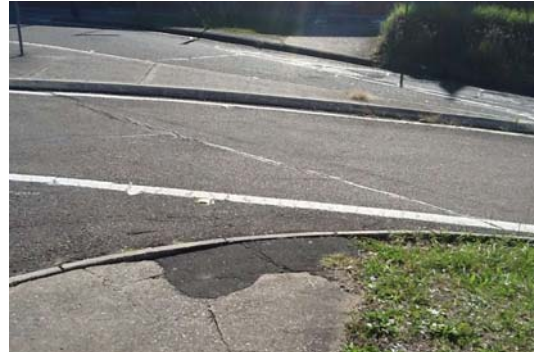
Ryde Road (at Burns Bay Road) missing kerb ramps

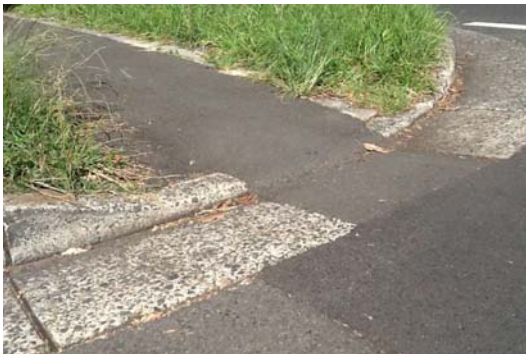
Ryde Road (at Figtree Road) has lip/step

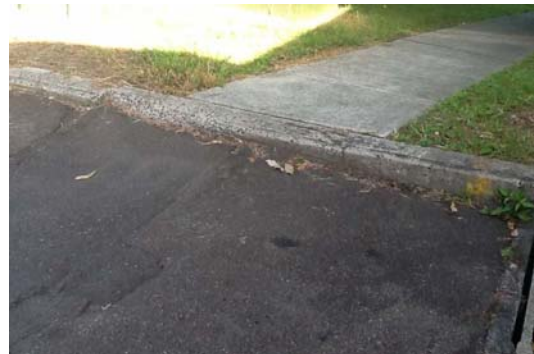
Ryde Road (at Figtree Road) has lip/step

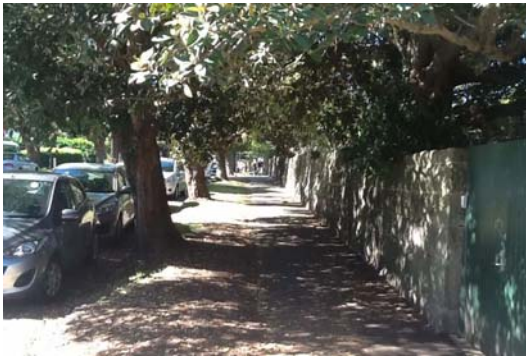
Gladesville Road (southern side)

Through the physical audit, street lighting was observed to be present along most of the high priority PAMP routes. However, the audit noted that a number of large trees with extensive foliage covered the street lights. This was especially evident along Gladesville Road and Ryde Road (northwest of the Village Centre), as well as Joubert Street south of Gladesville Road. Some examples are shown below.

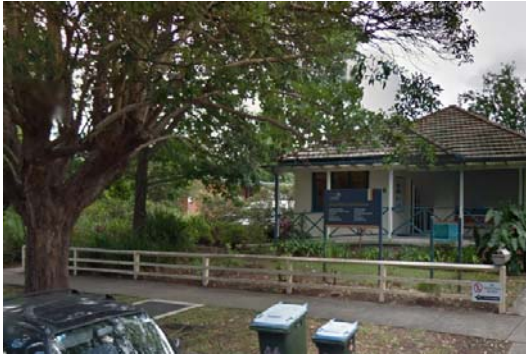
Signage in front of 46 Gladesville Road

There is limited wayfinding signage present within the Village Centre, with some examples shown in Photograph 22.

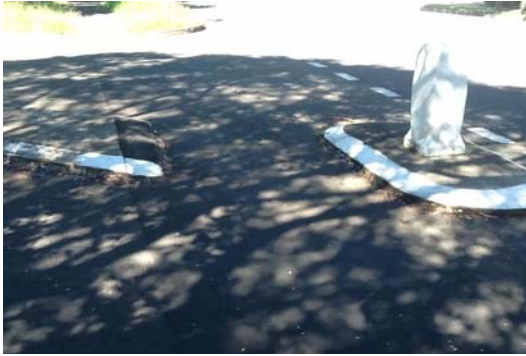
Figtree Road at Ryde Road intersection

Refuge islands within the study area were generally unprotected and not wide enough to accommodate a wheel chair user or bicycle. Refuge islands without handrails and sufficient width create a false sense of security for users crossing the road. Examples of poor refuge crossing points are shown below.

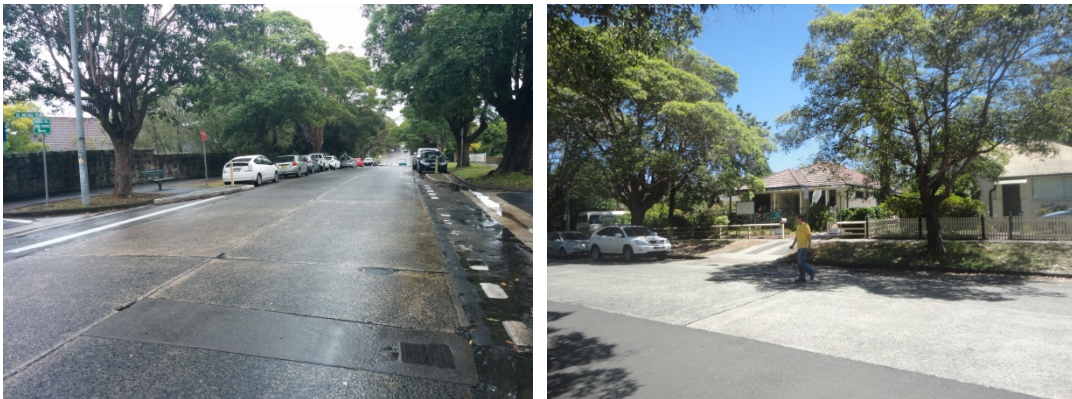
Photograph 5: Gladesville Road west of Ryde Road

The lack of a formal pedestrian crossing facility on Gladesville Road (west of Ryde Road) was a recurring issue to arise during the consultation period. On either side of Gladesville Road (between Ryde Road and Matthew Street), there is an intense concentration of aged care facilities and community facilities. Consequently, the vast majority of users crossing this road are elderly and less mobile – reflective of the age profile for Hunter's Hill as outlined on page 5 of this report. **A strong pedestrian desire line exists across Gladesville Road for users travelling between these facilities.**

Gladesville Road contains two traffic lanes in each direction, with the kerbside lane used for on-street parking. The road is currently signposted at 50km/h, however higher traffic speeds are often recorded as the road is wide and straight with good sight distance. Observations undertaken during this PAMP study have indicated a high number of elderly users cross the road during the day.

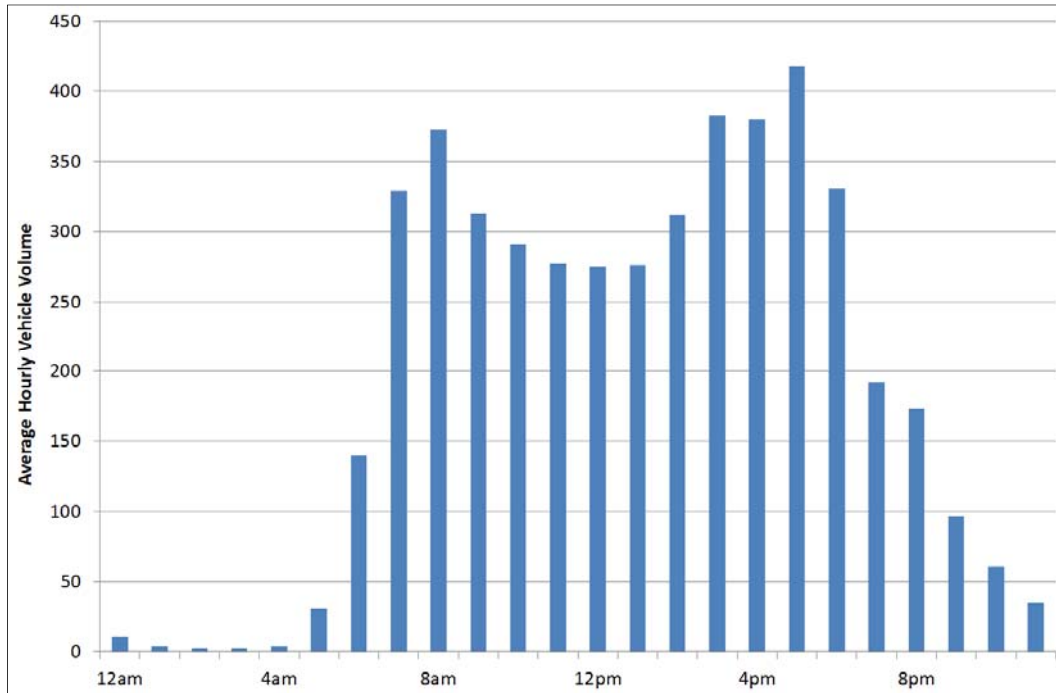
Figure 13: Gladesville Road traffic volumes

To understand the existing volume of traffic, and traffic speeds, Arup undertook a survey of all vehicles currently travelling along Gladesville Road. The survey was undertaken over a seven day period, between 2 May 2014 and 8 May 2014 (inclusive). A summary of the average hourly vehicle volumes on Gladesville Road is shown in Figure 13 below.

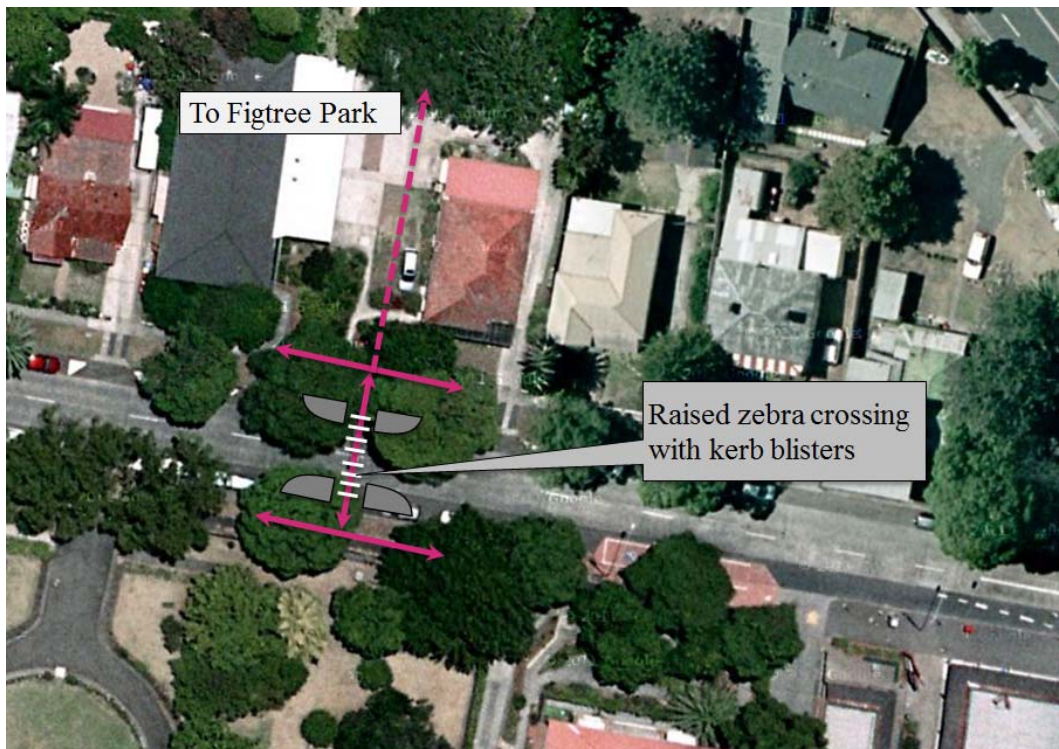
Figure 14: Proposed Gladesville Road Zebra Crossing

To align with the key pedestrian desire line, it is recommended the crossing be located adjacent to the driveway of 44 Gladesville Road (Community Centre). This will provide a linkage into Figtree Park further north. Introduction of this crossing will result in the loss of four on-street parking spaces on the southern side of Gladesville Road, and two spaces on the northern side.

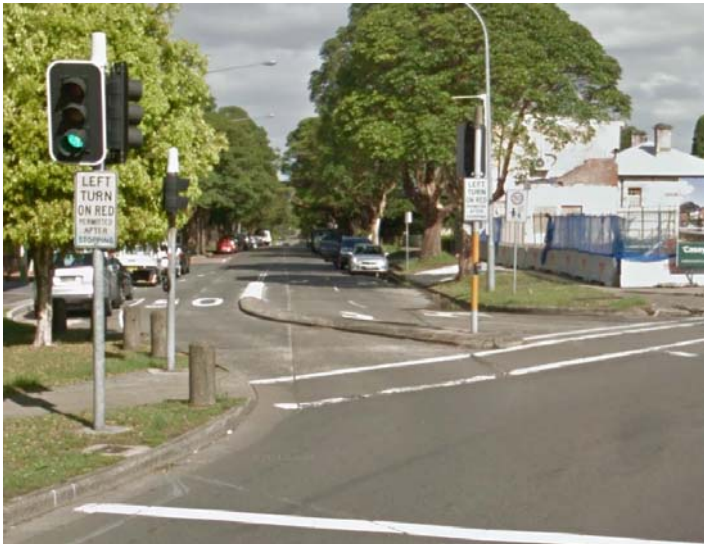
Figure 17: Gladesville Road / Ryde Road Intersection

An issue arising out of the community consultation was the unsafe crossing environment for pedestrians walking across Gladesville Road at the Ryde Road intersection. Currently when the pedestrian phase is activated (i.e. the 'green man' appears), drivers are given no indication to stop and give way. The lantern only contains a single column of traffic signals, with no left turn arrow present (see Figure 17). This results in pedestrians having to stop for motorists turning left onto Gladesville Road.

- New traffic signals on the south-western corner of the intersection be installed, which includes two columns of lights. When the pedestrian crossing phase across Gladesville Road is activated, a red left turn arrow will be called up to prevent drivers from turning left as pedestrians cross the intersection.
- The crossing be treated block paving / cobbles across the road to provide a visual indication to drivers of the presence of pedestrians. An example of this style of treatment is indicated in Photograph 6.

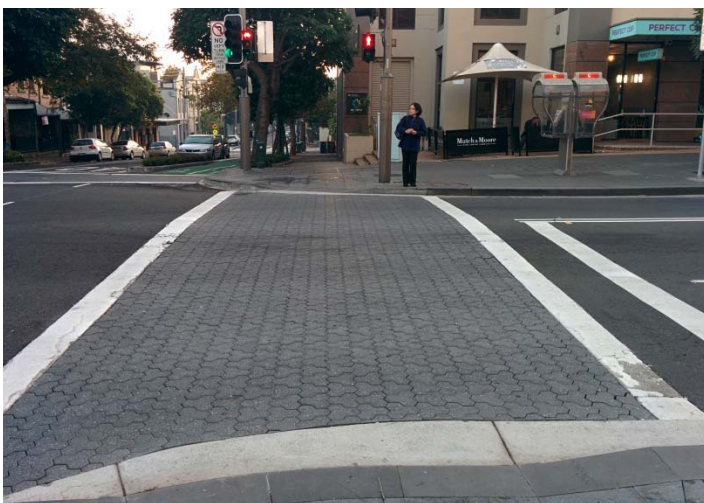
Photograph 6: Example of altered pavement surfacing at signalised crossing

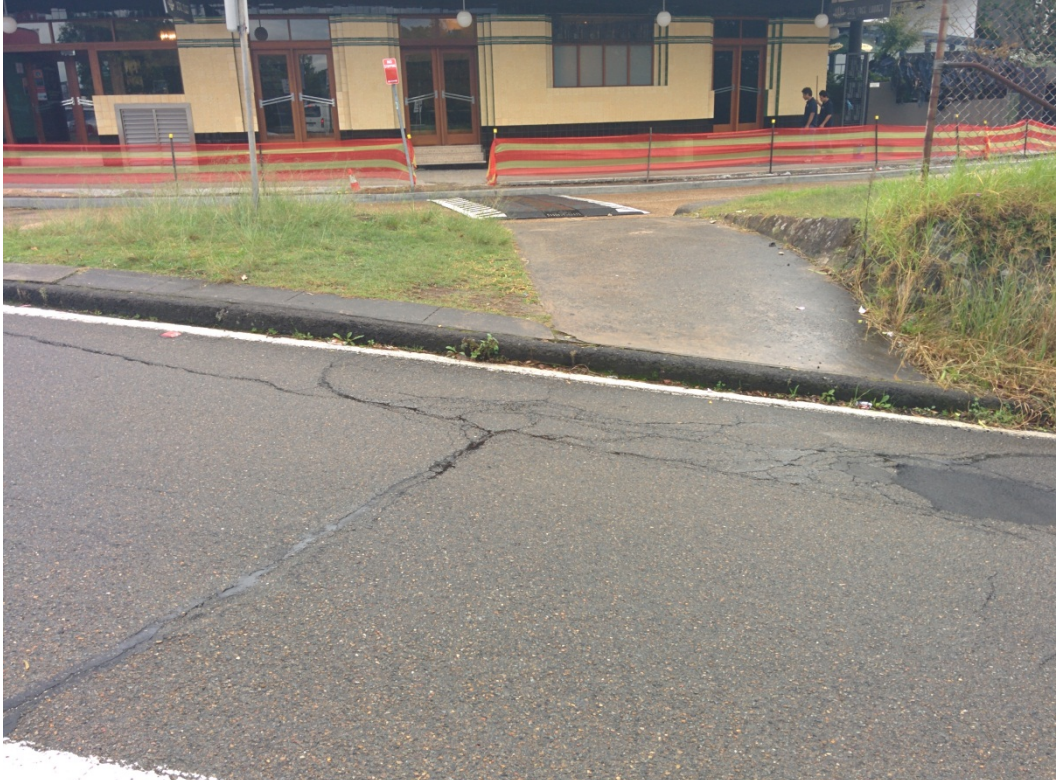
No formal crossing facility is currently provided for pedestrians crossing the northern side of Burns Bay Road (adjacent to the Hunter's Hill Hotel). Pedestrians must cross two slip lanes (Joubert Street and Burns Bay Road on-ramp) to access the overbridge. A high number of school children walk this route on a daily basis, between Hunter's Hill High School and the bus stop outside the Hunter's Hill Hotel. During the course of this study, Arup were made aware of a recent incident where a school aged child was struck by a vehicle turning left from Gladesville Road onto the Burns Bay Road on-ramp.

Photograph 7: Burns Bay Road Northern Crossing

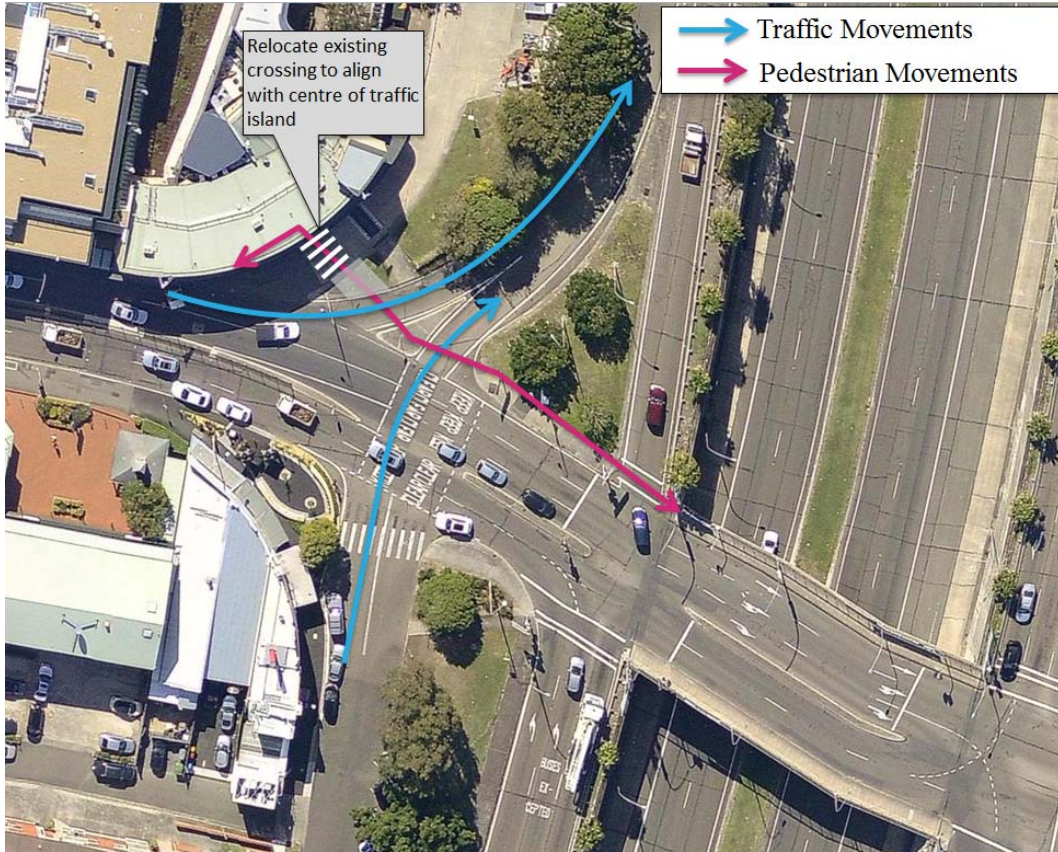
Figure 18: Option 1 – Burns Bay Road Crossing

Realign the existing raised speed table closer to Gladesville Road so pedestrians are directed to the centre of the traffic island. This will provide pedestrians with an improved line of sight to vehicles travelling north on Joubert Street, as well as directing them away from the narrow northern edge of the traffic island.

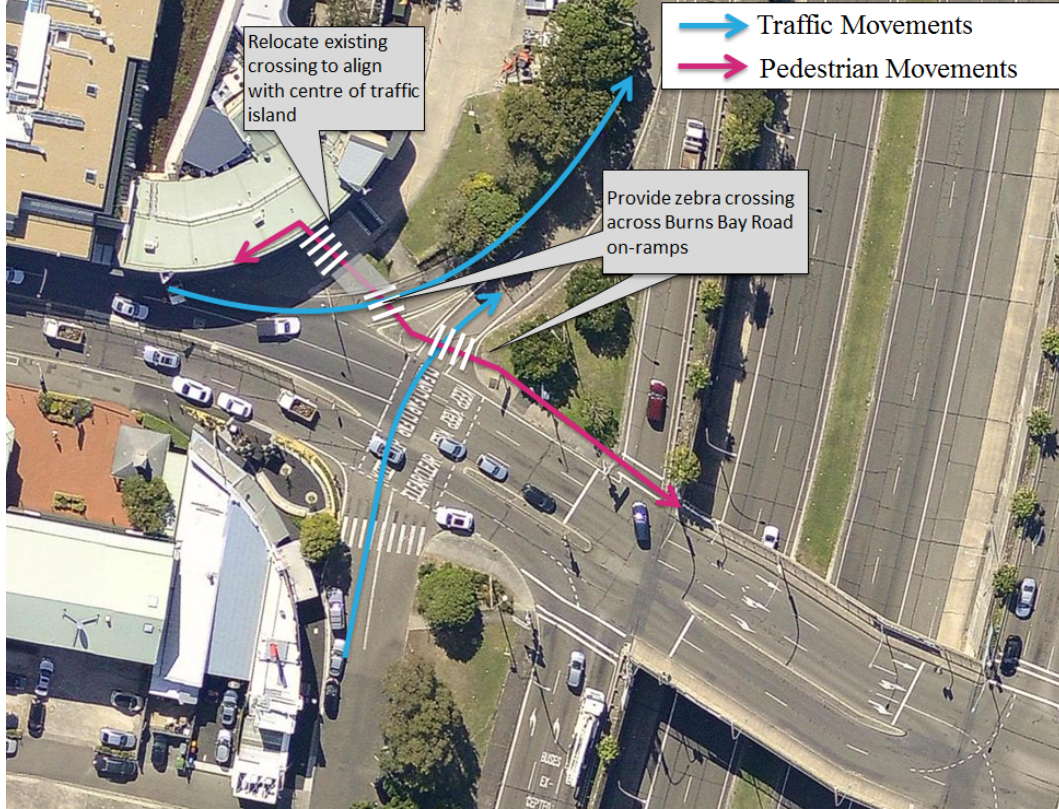
Figure 19: Option 2 – Burns Bay Road Crossing

As per option 1, however also provide zebra crossings across both on-ramps to Burns Bay Road.

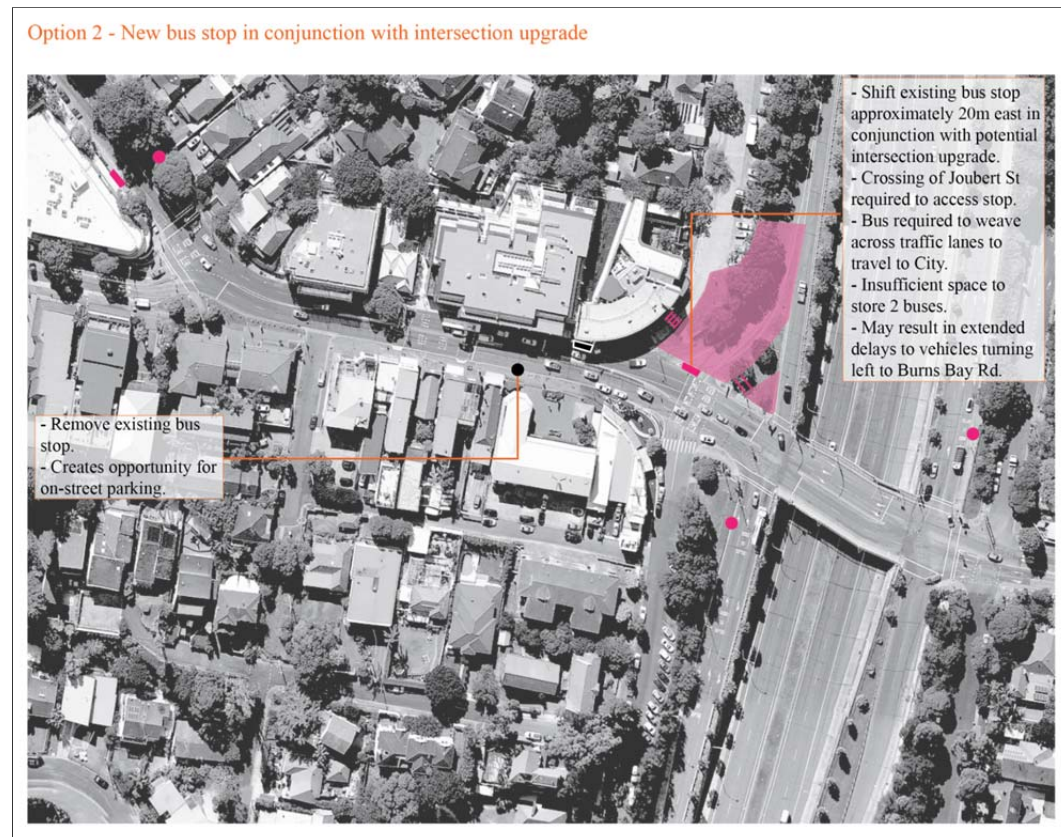
Figure 24: Option 2 – bus stops

This option was outlined in the Hunter’s Hill Traffic Study prepared by Chris Stapleton Consulting, and involves incorporating a new bus stop with intersection works on the northern side of Burns Bay Road. Key issues include:

- Pedestrians are required to cross Joubert Street (albeit at a new zebra crossing) to access the bus waiting area
- Cars turning left onto Burns Bay Road (travelling north) will be queued behind stopped buses, increasing traffic congestion on Gladesville Road
- There is insufficient space to simultaneously store two buses
- Buses turning right onto Burns Bay Road (travelling towards the CBD) are required to weave across two lanes of traffic. For this reason, bus drivers have previously expressed their opposition to this proposal
